Airworthiness Directive

AD No.: 2021-0042

ATA – Hot Air Balloons – Burner Assembly and Hanger – Inspection / Modification

(a) Service Bulletin No:	28
(b) Revision / Date	3 / 03-February-2021
(c) Title:	Stratus Double Burner, Burner Hanger Inspection
(d) Description:	Inspection / Replacement of Stratus Double Burner Hanger.

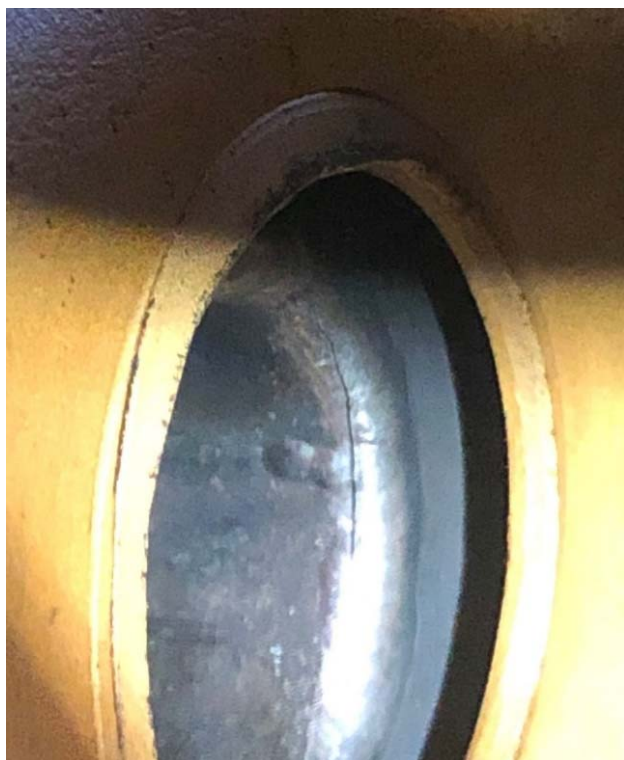
The failures appear to be caused by progressive fatigue cracking of the welded joint between the central tube and the end plate of the hanger assembly

Fig 1. Hanger with Weld Crack.

3/ Should any visible cracks be found further flight with the affected burner is not permitted. Report any observed defects to technical@cameronballoons.co.uk attaching photographs if available. Cracked hangers must not be re-welded. Repair affected burners by replacing the cracked hanger with a new issue D or later burner hanger.

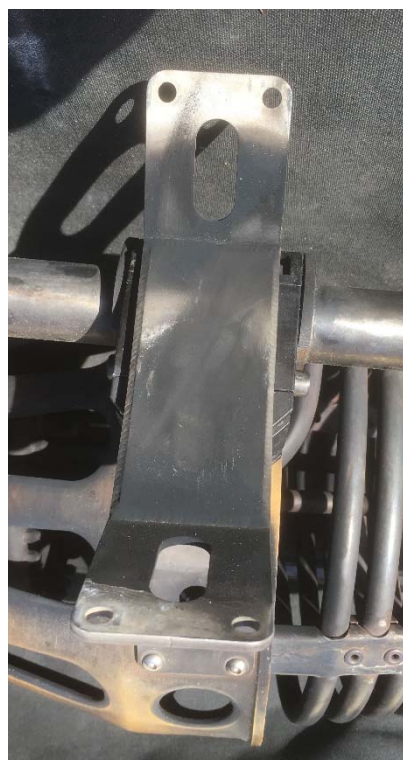
6/ A number of burners were produced in 1995 / 1996 using a doubler plate to reinforce the central part of the hanger bracket (Fig 2). The welded joint is hidden by the doubler plate and therefore impossible to inspect. Hangers of this design must be replaced by a new hanger CB8504-0000 Issue D or later.

Fig 2. Hanger with doubler plate.
