Airworthiness Directive

AD No.: 2021-0042

ATA – Hot Air Balloons – Burner Assembly and Hanger – Inspection / Modification

(a) Service Bulletin No:	28
(b) Revision / Date	3 / 03-February-2021
(c) Title:	Stratus Double Burner, Burner Hanger Inspection
(d) Description:	Inspection / Replacement of Stratus Double Burner Hanger.

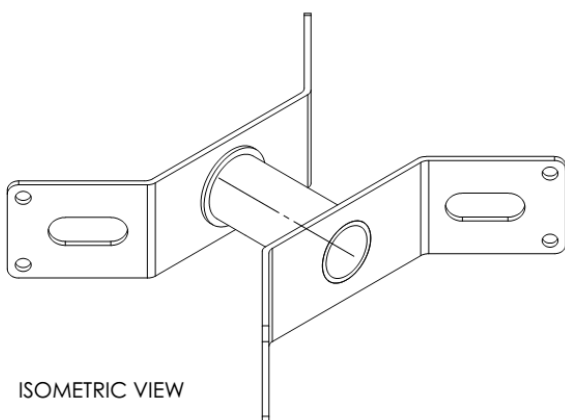
Fig 4. View of Hanger Assembly.

2.1.2 Affected hangers (Issues A through C) have either no machine engraving or have “Cameron Balloons Limited” machine engraved in the upper right-hand corner of the end plate. Non-affected hangers (Issue D and E) have the text “Cameron Balloons Limited” machine engraved in the lower right-hand corner of the end plate.
